# San Fernando, California, Earthquake of February 9, 1971

U.S. DEPARTMENT OF COMMERCE  
National Oceanic and Atmospheric Administration

*Part B. Buildings continued; Soils and Foundations*

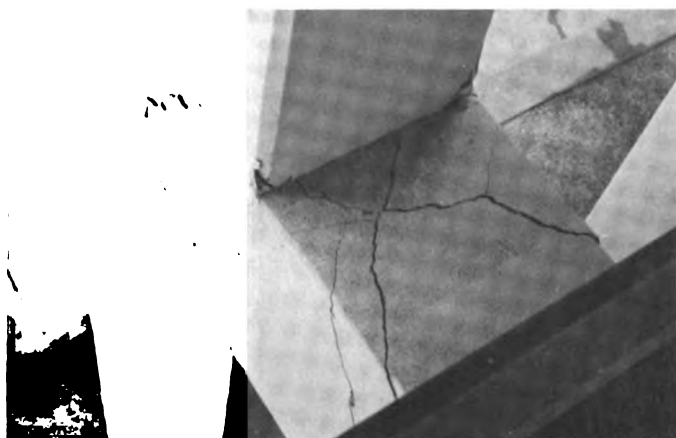
Generally, visible structural damage was slight and consisted almost entirely of minor cracking and spalling of concrete (figs. 10 and 11). However, in some areas, extensive cracking occurred, particularly at the exposed girder stubs at the exterior columns along the second-floor level (figs. 12 and 13).

At the second floor, girders projecting beyond the spandrel line were damaged. The parapet on the one-story low roof structure attached to the main building also was damaged. The torsion induced in girder stubs projecting from columns on the north and south sides caused cracking as shown in figures 12 and 13. The stubs are located at alternate columns, except at corners, and for the north and south sides were not considered seismic force-resisting elements. Girder stubs on the west side also showed some bending cracks.

Figure 13.—Bank of California. Top view of second-floor girder-column connection shown in figure 12. Evidence of torsional cracking resulting from offset spandrels is apparent. Brandow & Johnston photograph.

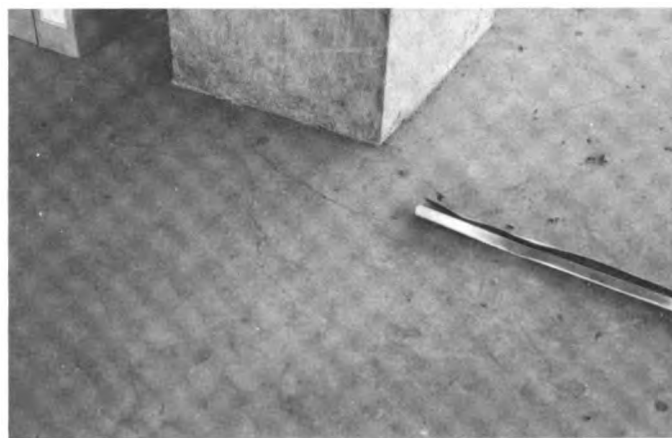
At these same levels, interior columns experienced no damage, but a series of cracks was observed in the floor slab around columns (fig. 16). Corner columns revealed some hairline cracks on a slight diagonal ex-

Figure 16.—Bank of California. Type of floor and girder cracking found near second interior column, in from north end of the building on both fourth and fifth floors. Brandow & Johnston photograph.

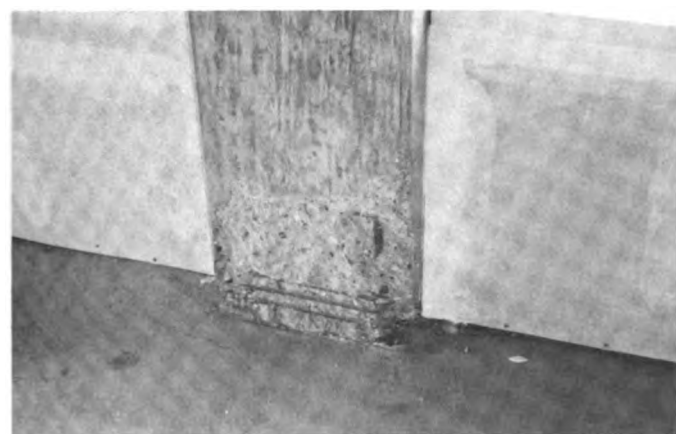
At floor level on the third, fourth, and fifth floors, exterior columns typically spalled (figs. 14 and 15). On the east and west sides of the building, spalling also occurred at the top of the columns, but only on the interior column face. On the east and west sides, some spandrels showed areas of spalling near the columns.

Figure 14.—Bank of California. Spalled area on interior face of exterior column. Column reinforcing has been further exposed by chipping. Brandow & Johnston photograph.

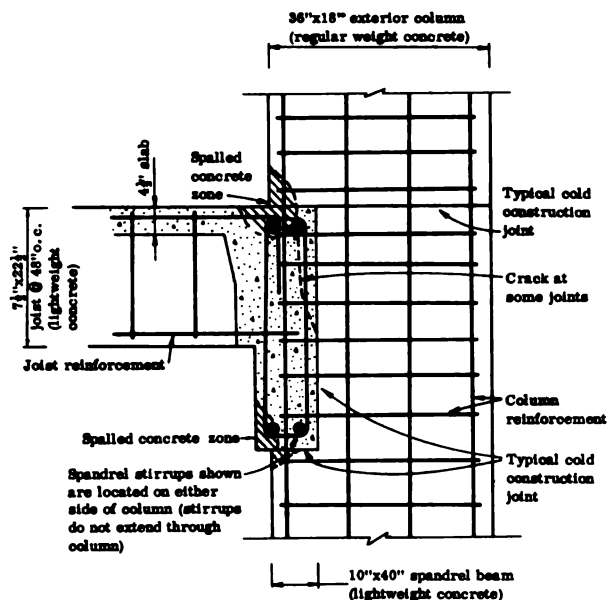
The spandrel-column detail shown in figure 18 facilitated construction (concrete pours) from the fourth floor to the roof. Major joint rotation and column or spandrel spalling coincided with areas where this detail was used (figs. 19, 20, and 21).

Figure 18.—Bank of California. Typical construction of exterior column-spandrel-joint connection from fourth floor to roof.

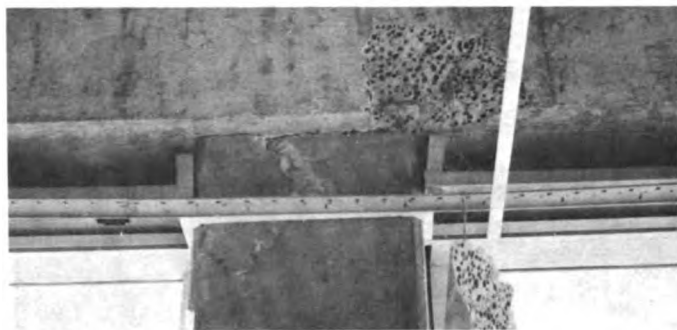
Figure 19.—Bank of California. Spalled lightweight concrete on fifth-floor spandrel. Note also chipped concrete on left side of column. Brandow & Johnston photograph.

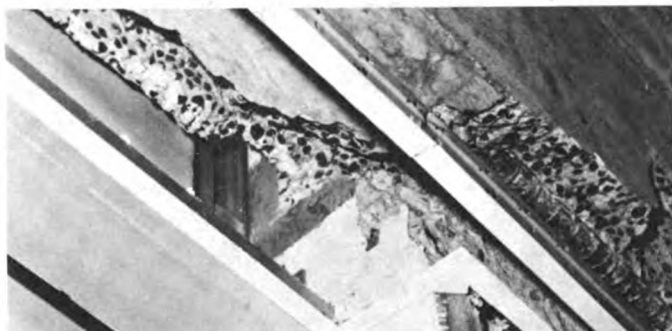
Figure 20.—Bank of California. Spalled concrete in joint zone of spandrel and exterior column. Spandrel is offset from column centerline. Little flexural cracking was evident in members on either side of joint. Note main bottom reinforcing without confining stirrups within column zone. Brandow & Johnston photograph.

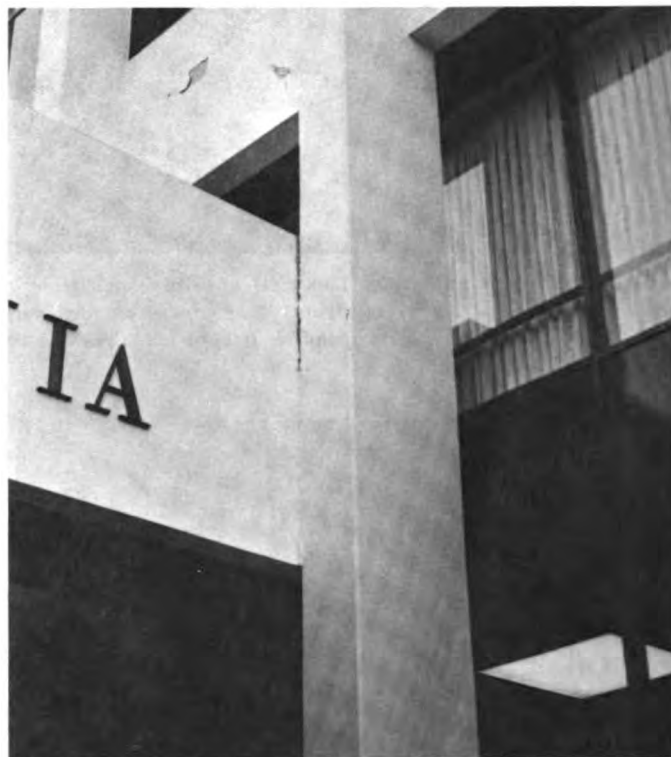
Figure 22.—Bank of California. Low roof connection to office tower columns at second-floor level. Original building plans specified a seismic separation at this point, but this detail was poured monolithically during construction. Brandow & Johnston photograph.

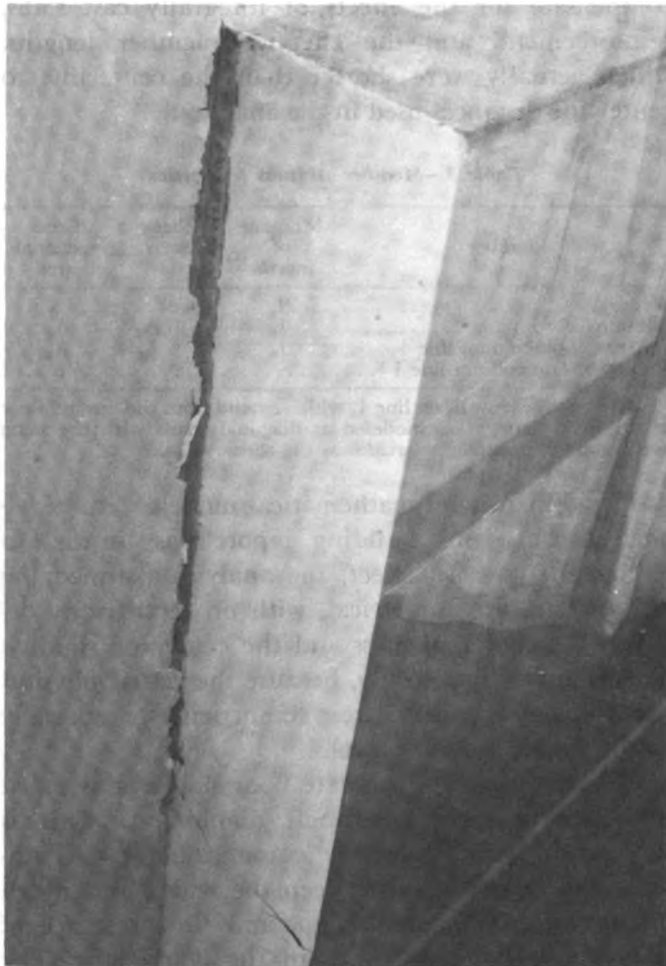
Figure 23.—Bank of California. Closeup detail of figure 22. Brandow & Johnston photograph.

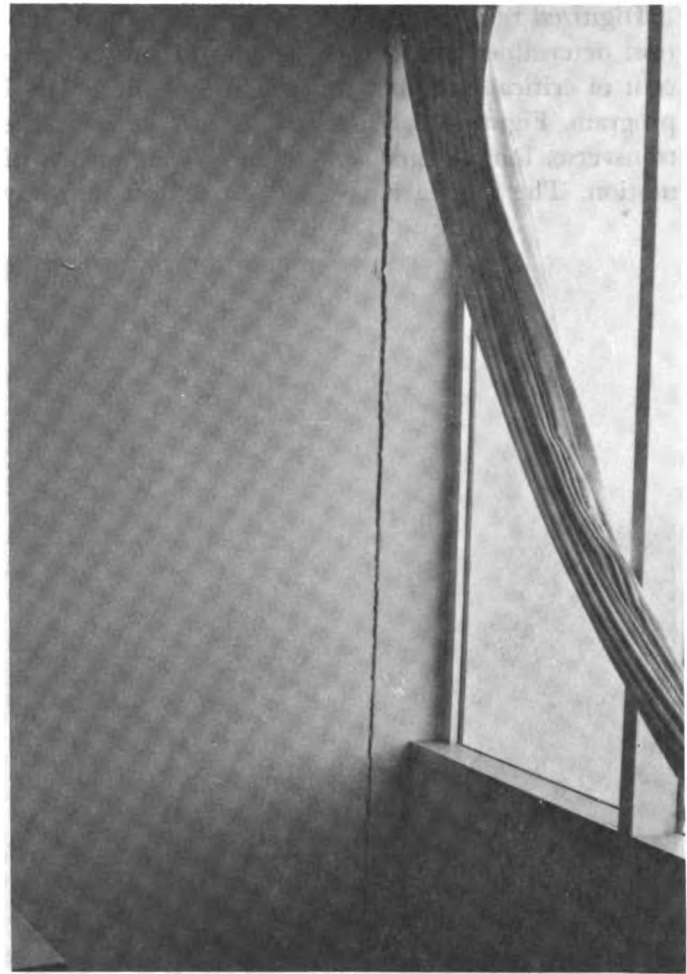
Nonstructural damage was distributed extensively between the sixth and 11th floors. Partitions running in an east-west direction pulled away from east and west exterior columns as shown in figure 24. Thus, ceiling tiles fell out. Between the third and fifth floors, some bolts on east-west spanning stairs were pulled from concrete floor beams. Partition cracking also occurred in the stairwells at these levels (fig. 25), decreasing below the fourth floor. At the second-floor level, windows shifted in the mullions on the north and south sides of the building.

Figure 24.—Bank of California. Cracking in drywall partitions provided an indication of interstory deflections. This east-west running partition separated substantially from the east exterior curtain wall. Brandow & Johnston photograph.

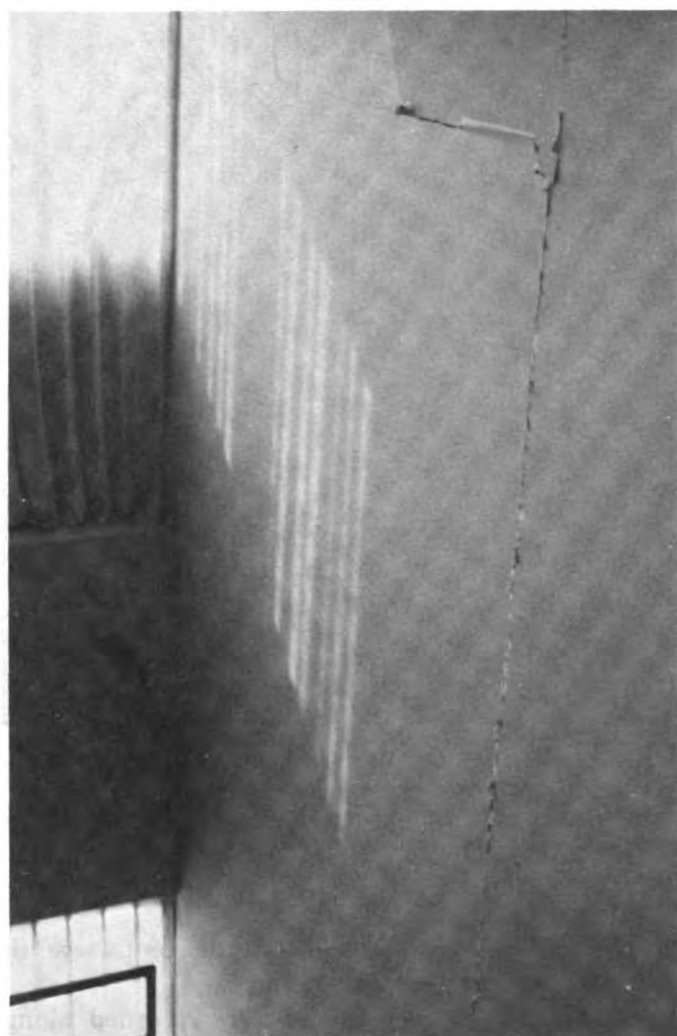
Figure 25.—Bank of California. Side walls of northwest stairwell showed signs of "working" during the earthquake. Brandow & Johnston photograph.

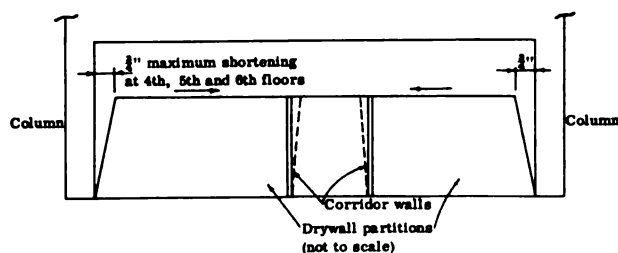
The east-west running gypsum wallboard on steel stud partitions was fastened to both the floor and suspended ceiling. As the building displaced laterally during the earthquake, racking of the partitions and shortening of the hung ceiling took place. As illustrated in figure 26, the ceiling level shortened as much as  $\frac{3}{4}$  inch. This indicated story drifts of at least  $\frac{3}{4}$  inch. Such partition and ceiling displacements were observed at the fourth, fifth, and sixth floors, and to a lesser extent at the seventh, eighth, and ninth floors.

Figure 26.—Bank of California. Shortening of transverse drywall.

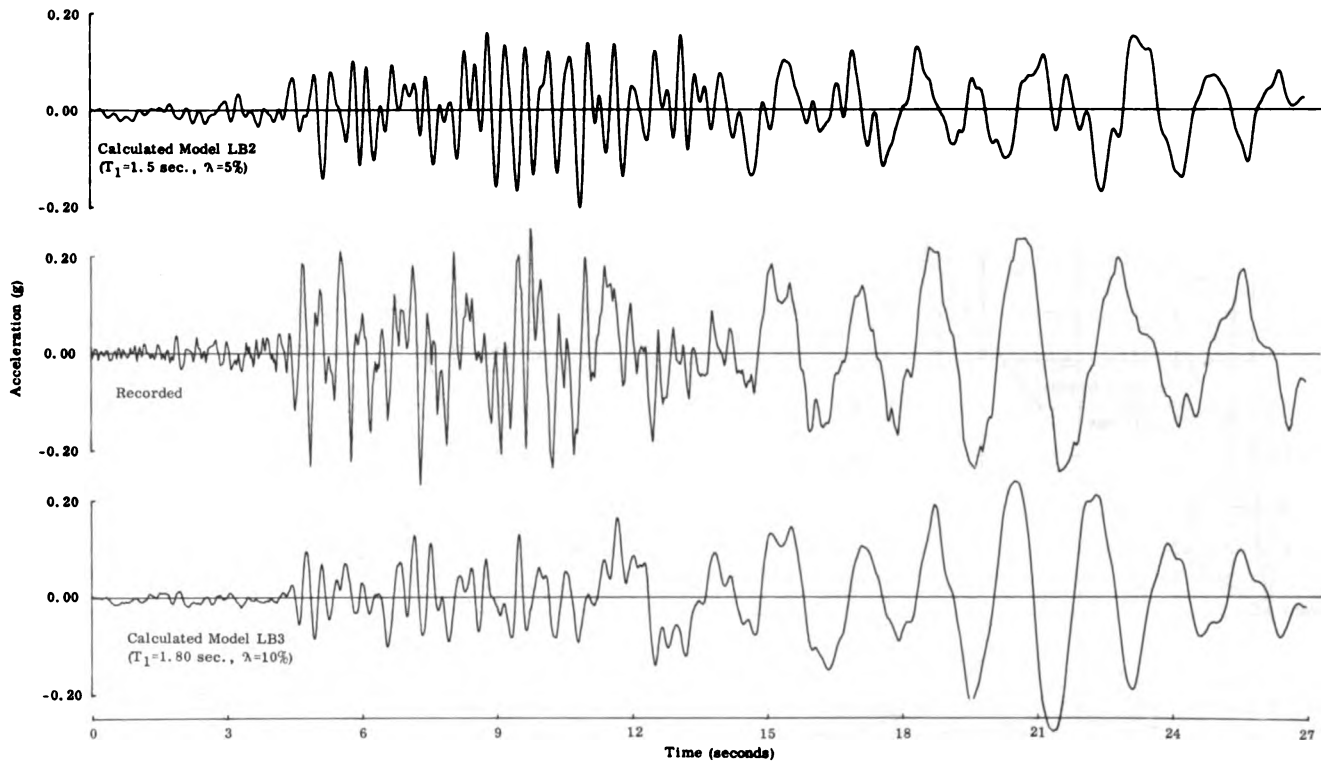
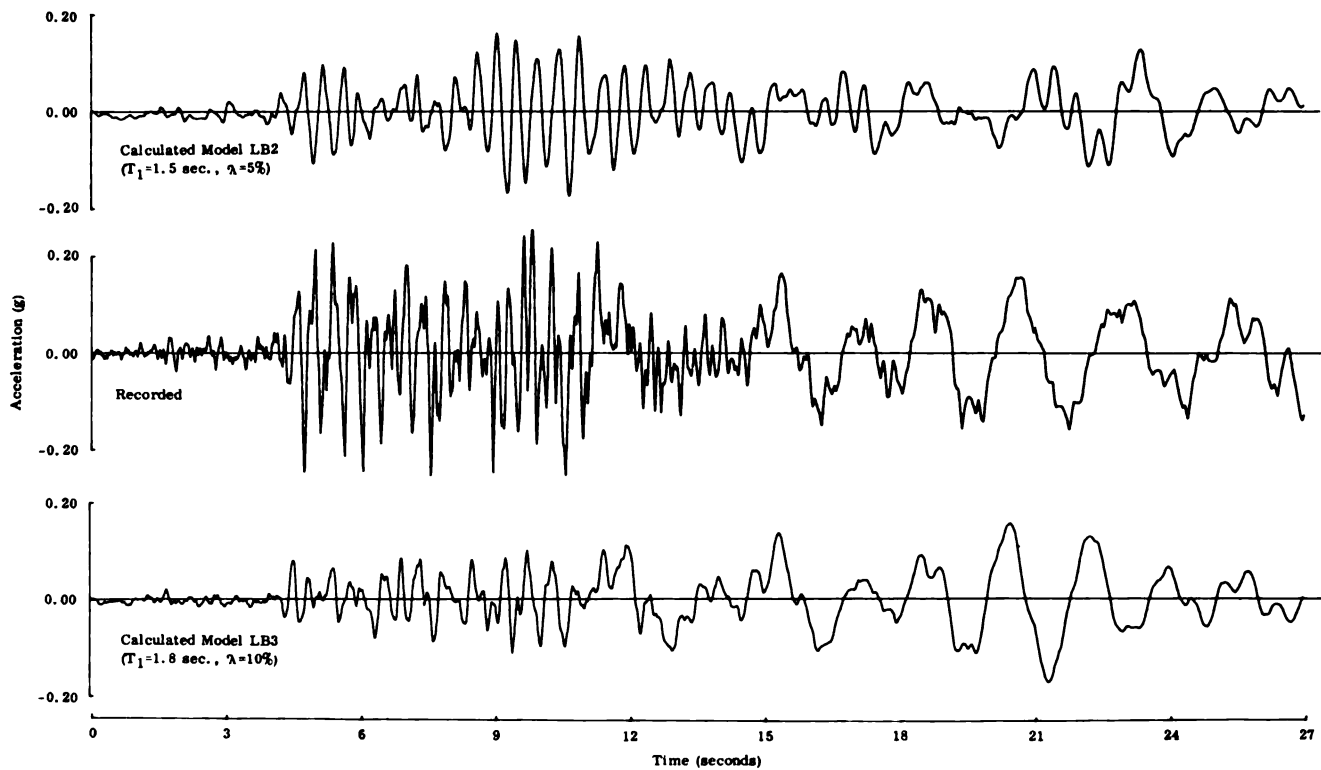
Figure 37.—Bank of California. Longitudinal calculated and recorded accelerations.

Figure 37 shows two computed and one recorded acceleration time-history plot for the longitudinal roof component. That part of the computed response for model LB3 between 13 and 21 seconds correlates reasonably in periodicity and amplitude with the recorded results. However, at approximately 21 seconds, the recorded accelerations reach a relatively broad peak of high amplitude. The recorded accelerations immediately following the 21-second mark show a pronounced lengthening of period. This can be attributed to the pulse at 21 seconds causing additional yielding of reinforcement, cracking, and spalling of concrete, thereby lengthening the building's predominant period of response from approximately 1.8 to roughly 2.5 seconds.

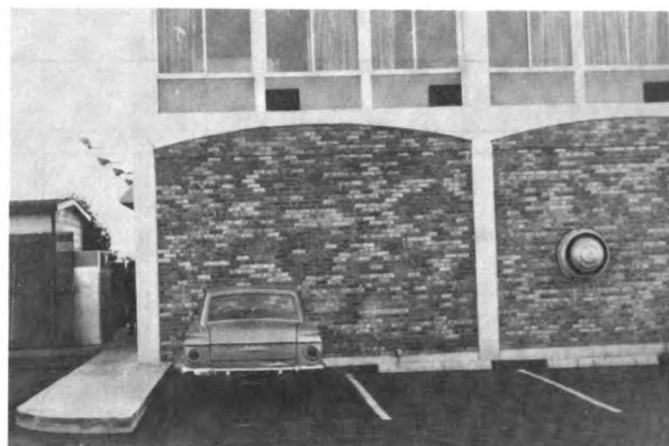
Figure 8.—Holiday Inn, Orion Avenue. East end of north side of building. Crack at second-floor beam-column joint. John A. Blume & Associates photograph.

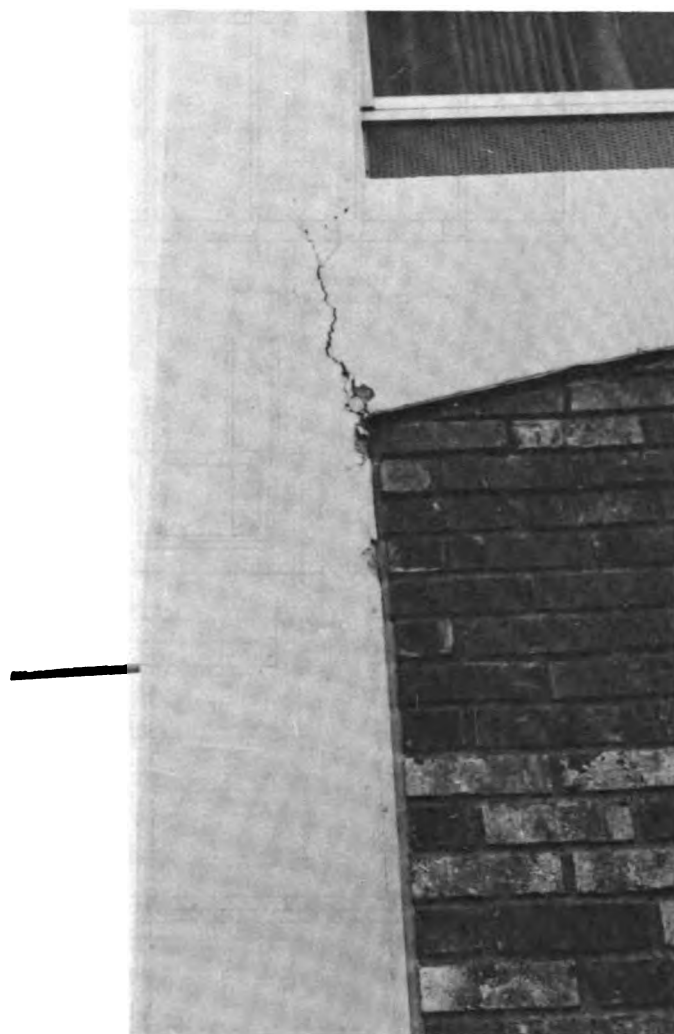
Figure 9.—Holiday Inn, Orion Avenue. Closeup view of figure 8. John A. Blume & Associates photograph.

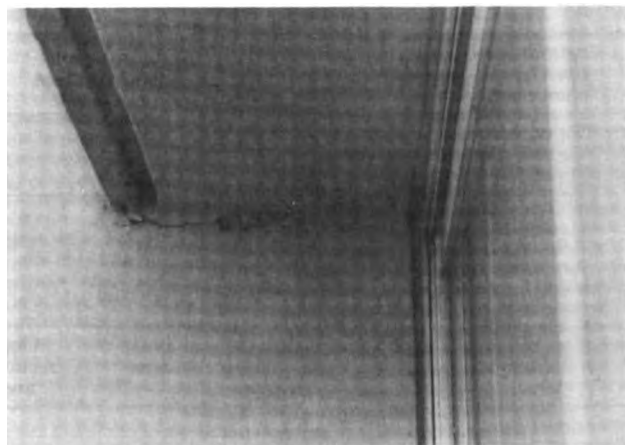
Figure 10.—Holiday Inn, Orion Avenue. Exterior spandrel beam-to-column connection. Shallow cracking at column pour joint. General Adjustment Bureau photograph.

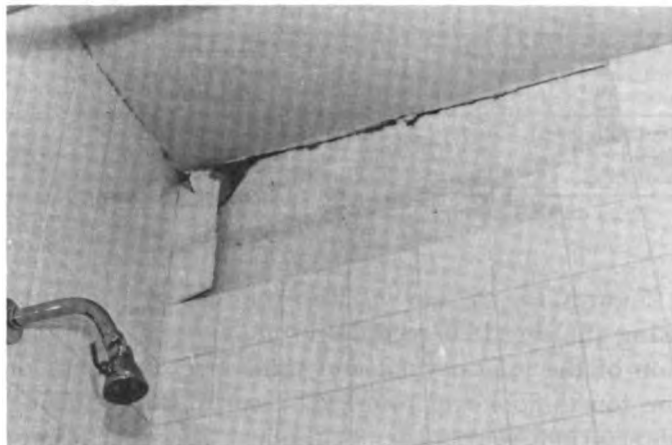
Some gypsum wallboard panels had to be replaced. Interior partitions required paint and new vinyl wall covering (fig. 11). Forty-five bathtubs (fig. 12) and 12 water closets had to be replaced. Bathroom tile had to be patched, grouted, or replaced in over half of the bathrooms (fig. 13). Spalling occurred at architectural concrete attached to structural concrete columns at the ground floor (fig. 14). Exterior cement plaster spalled and cracked. Windows in every room required some alignment and caulking, although none needed replacing. Doors needed adjustment.

Figure 13.—Holiday Inn, Orion Avenue. Damage to tile above bathtub on second floor. John A. Blume & Associates photograph.

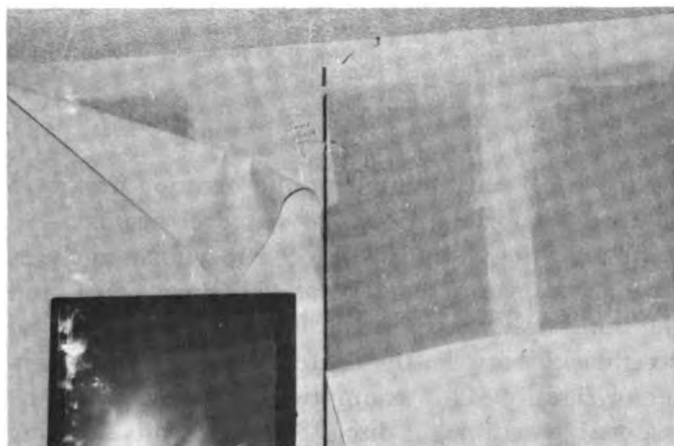
Figure 11.—Holiday Inn, Orion Avenue. Break in gypsum wallboard on second floor. John A. Blume & Associates photograph.

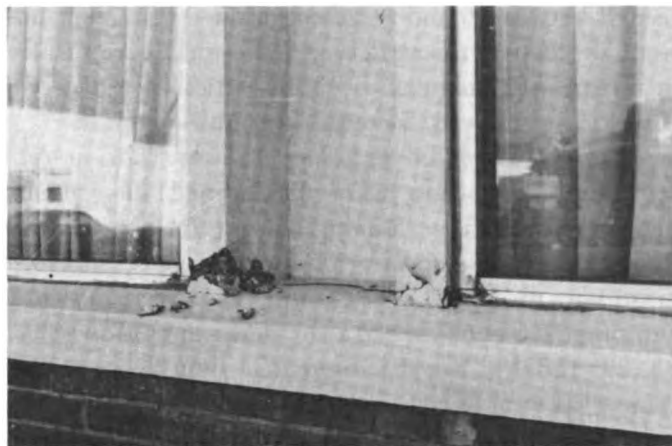
Figure 14.—Holiday Inn, Orion Avenue. Spalling of architectural concrete at first-floor column, north side. John A. Blume & Associates photograph.

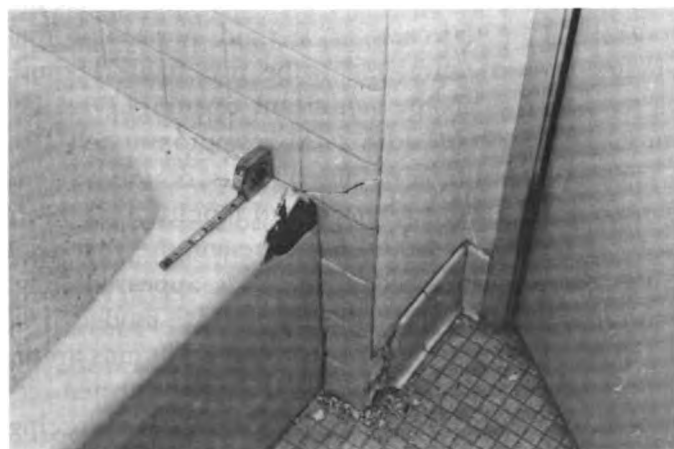
Figure 12.—Holiday Inn, Orion Avenue. Damage to bathtub at second floor. John A. Blume & Associates photograph.

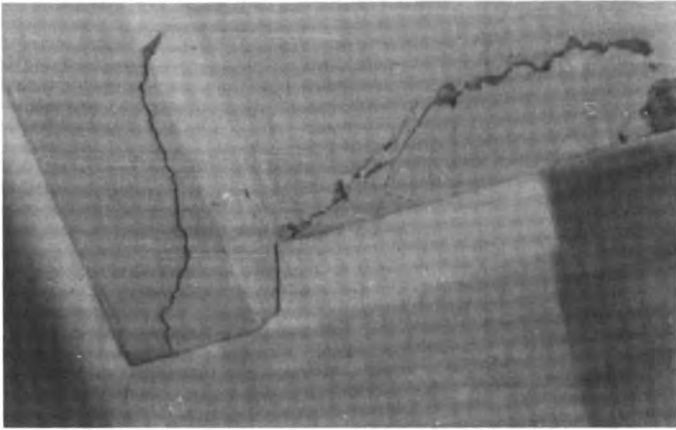
Figure 8.—Holiday Inn, Marengo Street. Interior view of beam and slab soffits at intermediate stair landing. General Adjustment Bureau photograph.

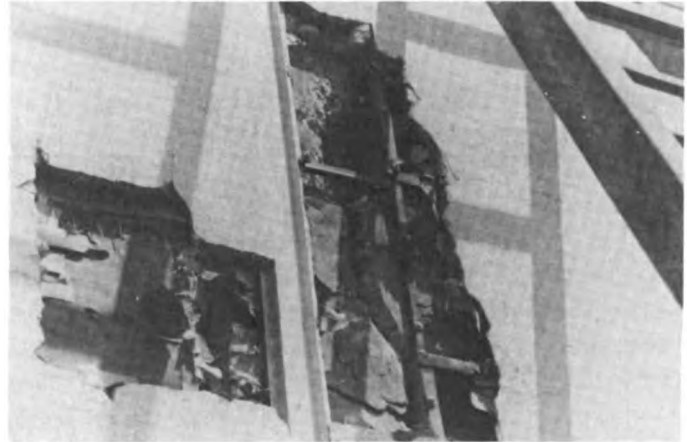
Figure 11.—Holiday Inn, Marengo Street. Closeup view of beam-column joint shown in figure 10 before all the plaster was removed. General Adjustment Bureau photograph.

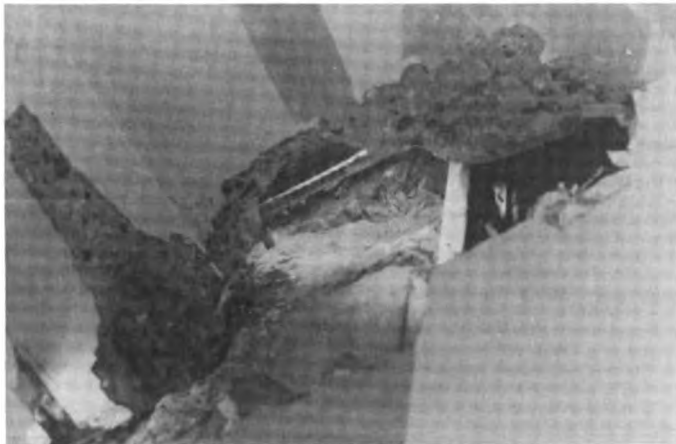
Figure 9.—Holiday Inn, Marengo Street. Same view as figure 8 after damaged concrete has been removed. General Adjustment Bureau photograph.

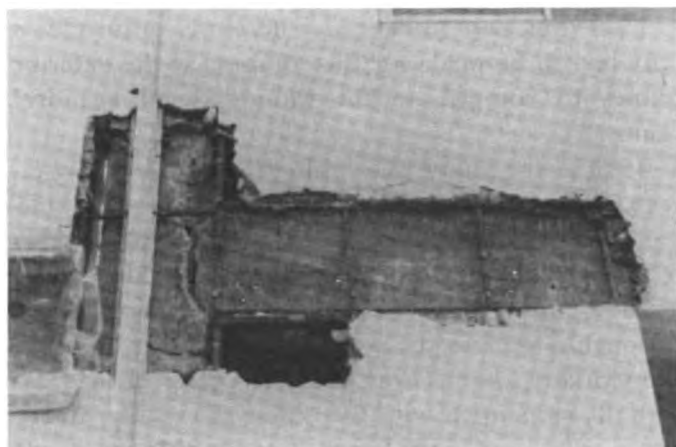
Figure 10.—Holiday Inn, Marengo Street. Exterior view of damage to beam-column joint at the intermediate stair landing. General Adjustment Bureau photograph.

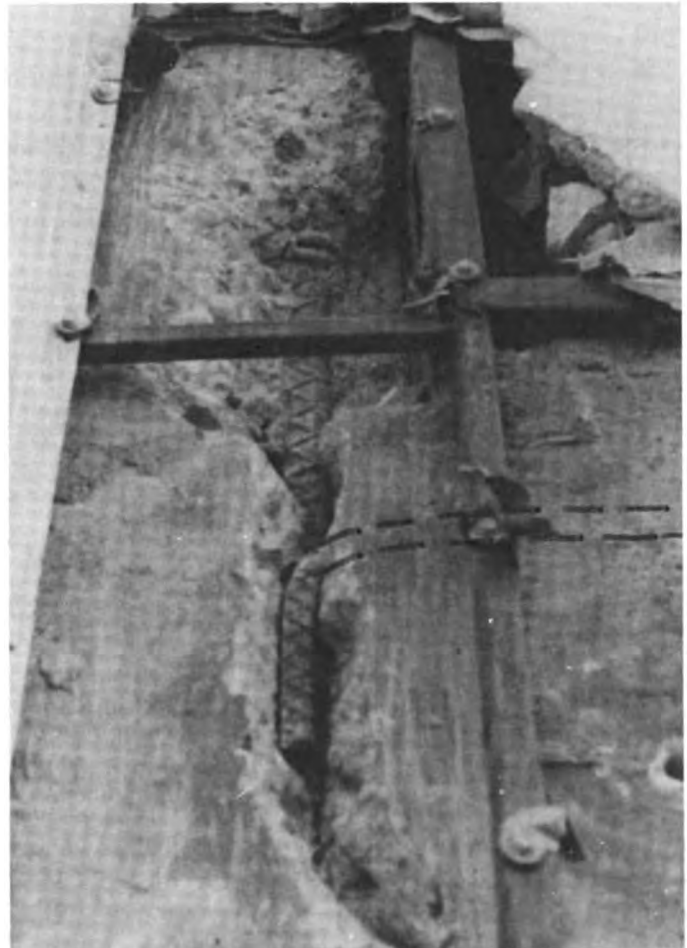
Figure 12.—Holiday Inn, Marengo Street. Closeup view of figure 11 showing exposed reinforcing bars at beam-column joint. General Adjustment Bureau photograph.

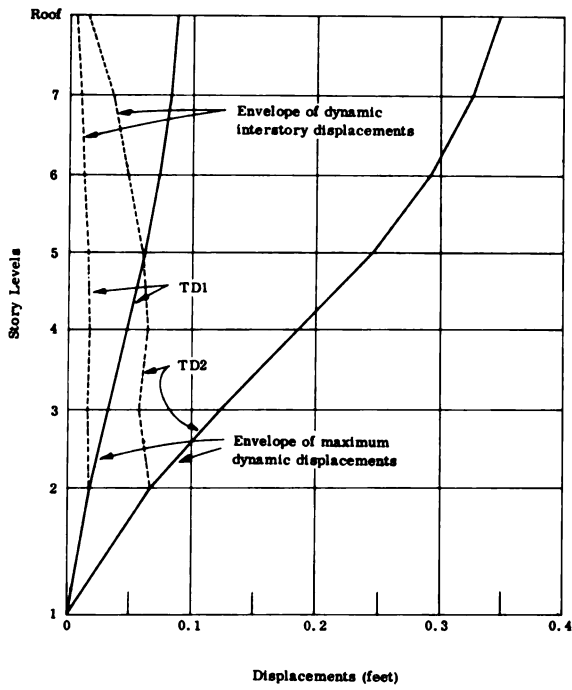
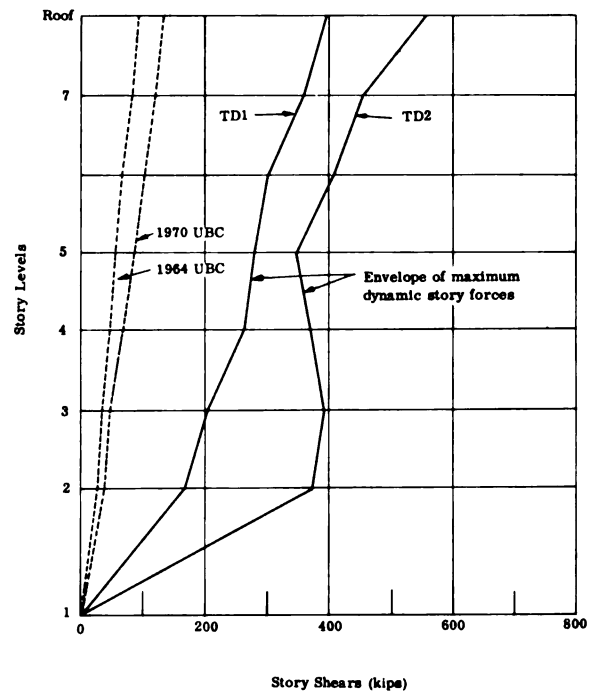
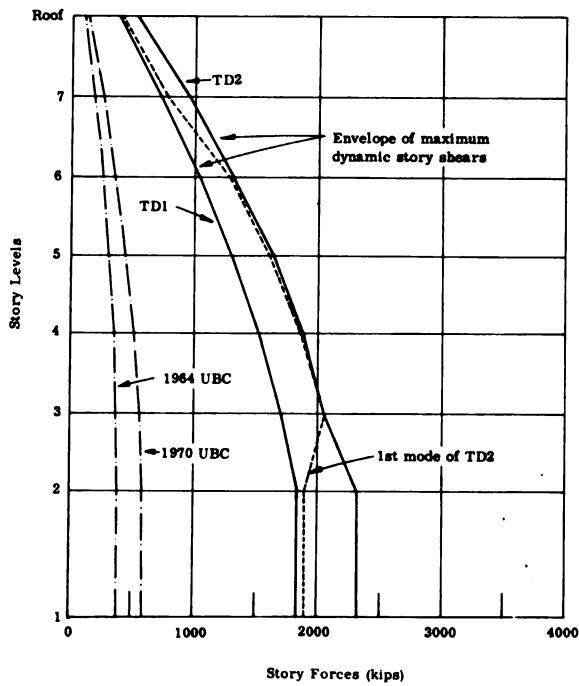
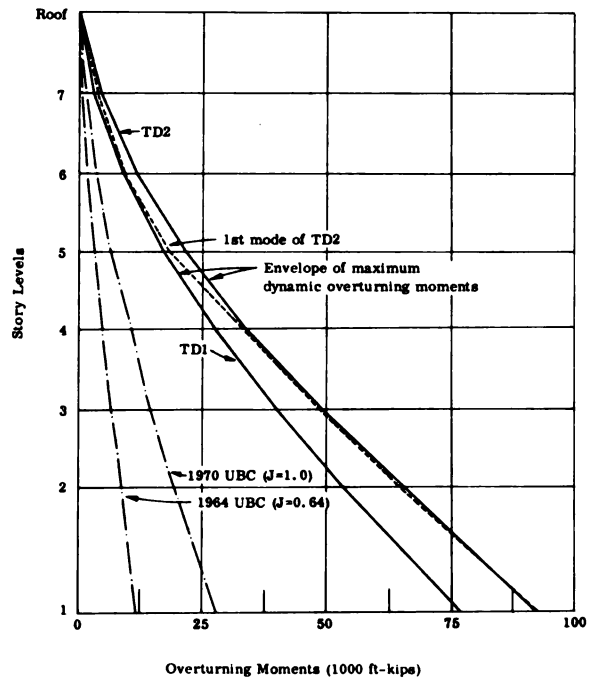
Figure 24.—Holiday Inn, Marengo Street. Dynamic response and design code values for transverse (52°W.) direction.

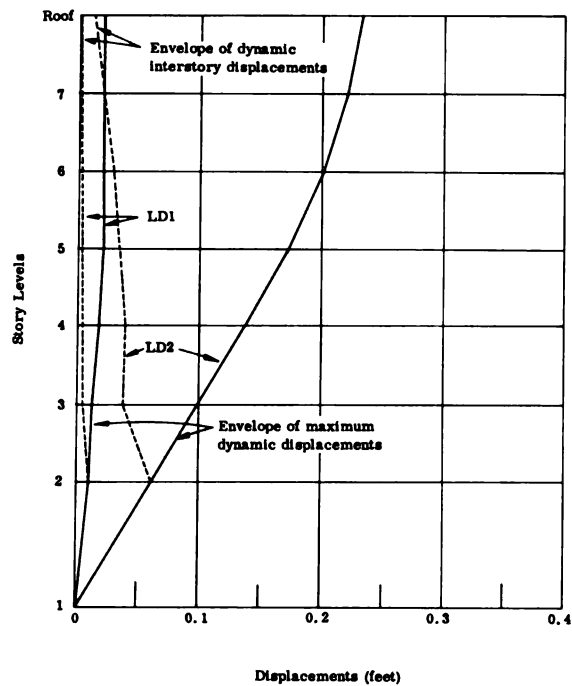
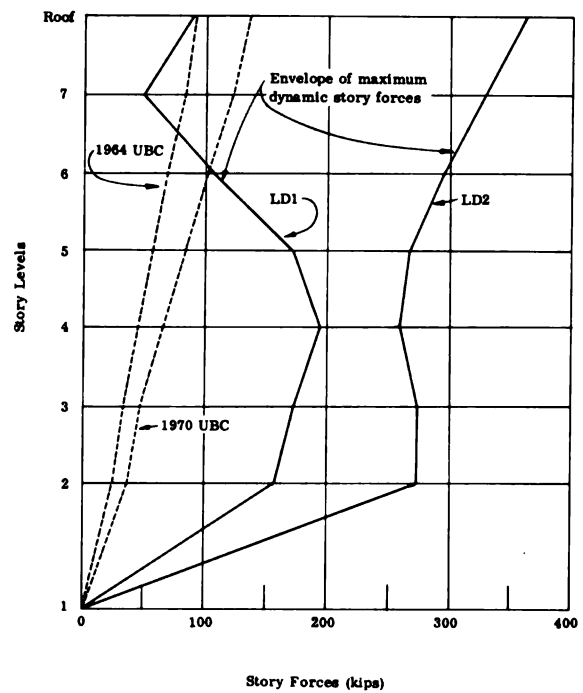
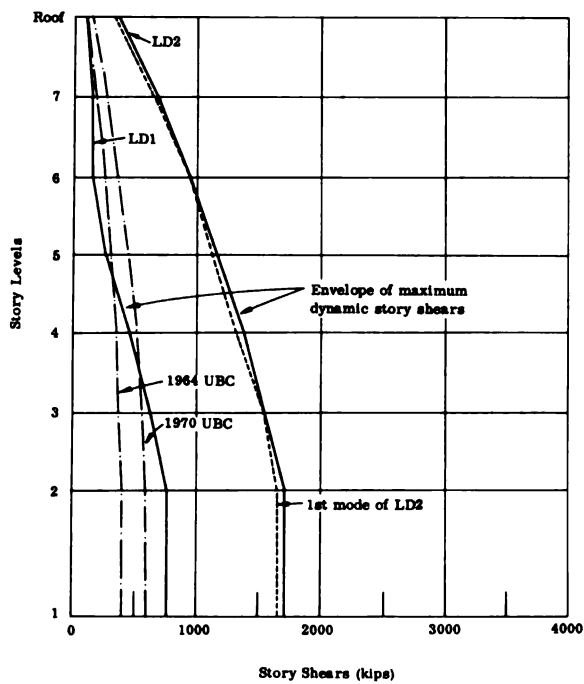
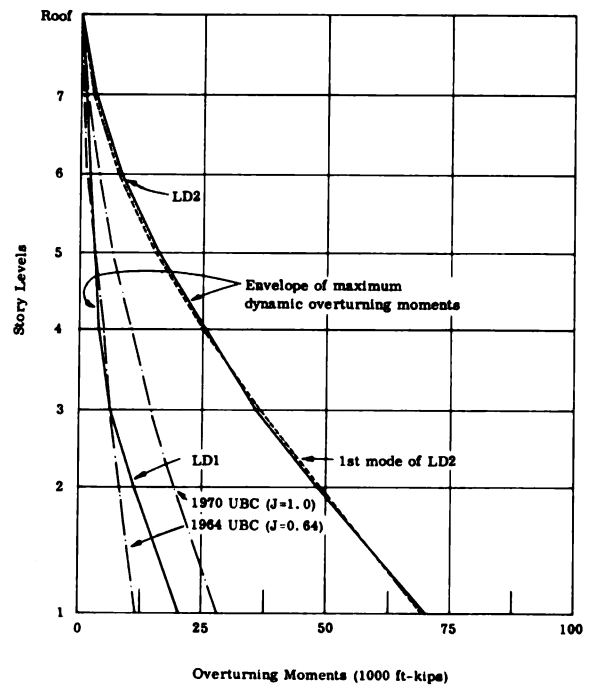
Figure 25.—Holiday Inn, Marengo Street. Dynamic response and design code values for longitudinal (N38°W.) direction.

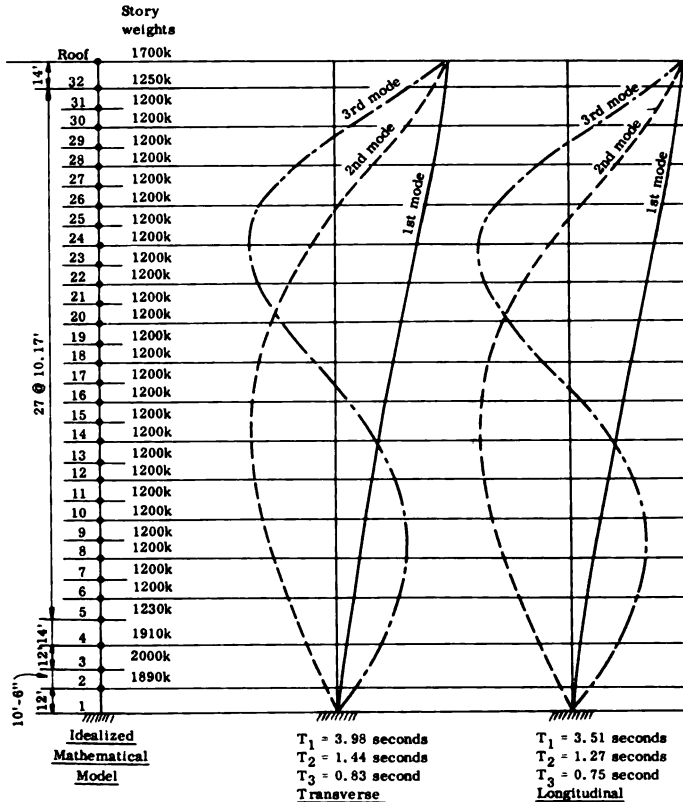
Figure 15.—Bunker Hill Tower. Calculated periods and mode shapes.

The calculated fundamental periods for the bare structural steel frame are approximately 4.0 seconds in the transverse direction and 3.5 seconds in the longitudinal direction (fig. 15). Fundamental periods implied in the records of motion, which become apparent after 20 seconds of motion (fig. 16), are approximately 4.0 seconds in the transverse direction and 3.4 seconds in the longitudinal direction. This comparison provided some help in determining the accuracy of the mathematical models, but verification was complicated by other factors.

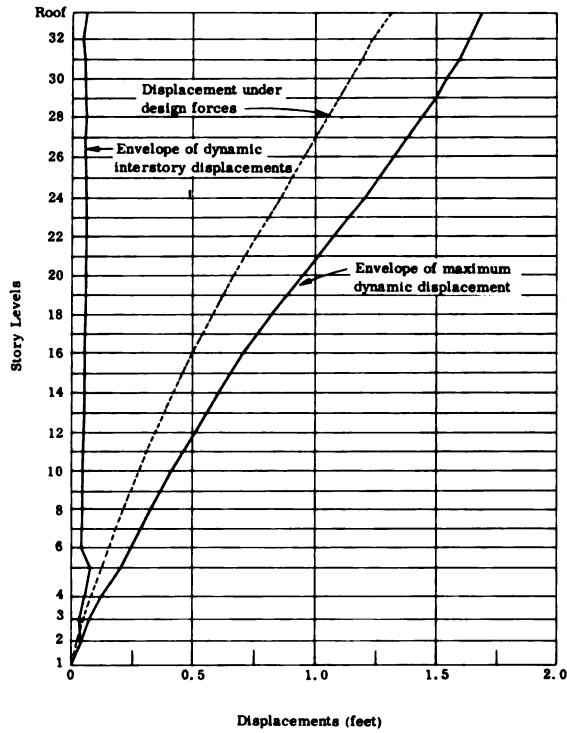
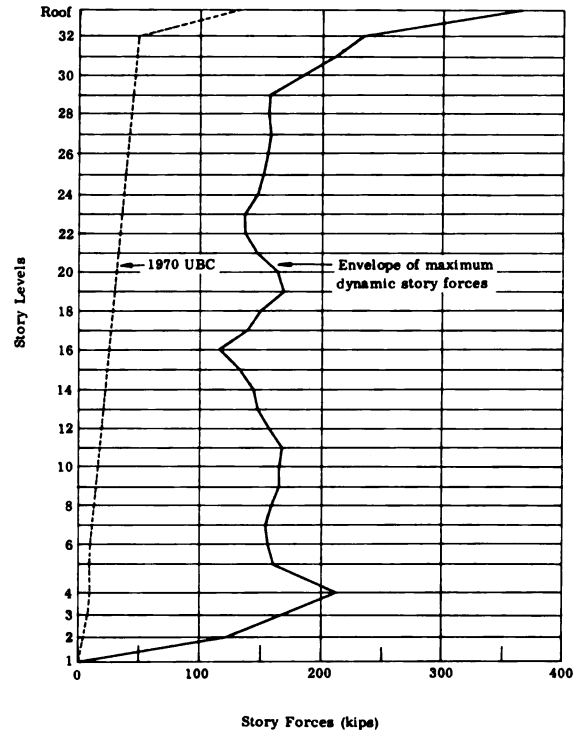
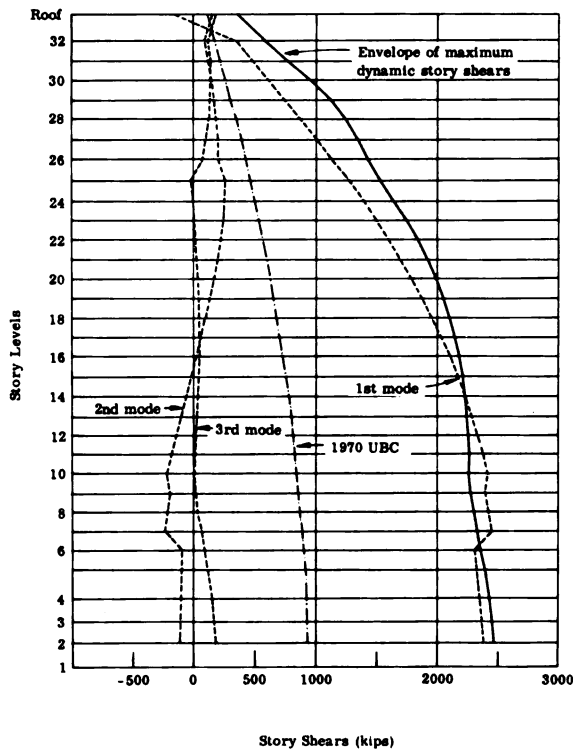
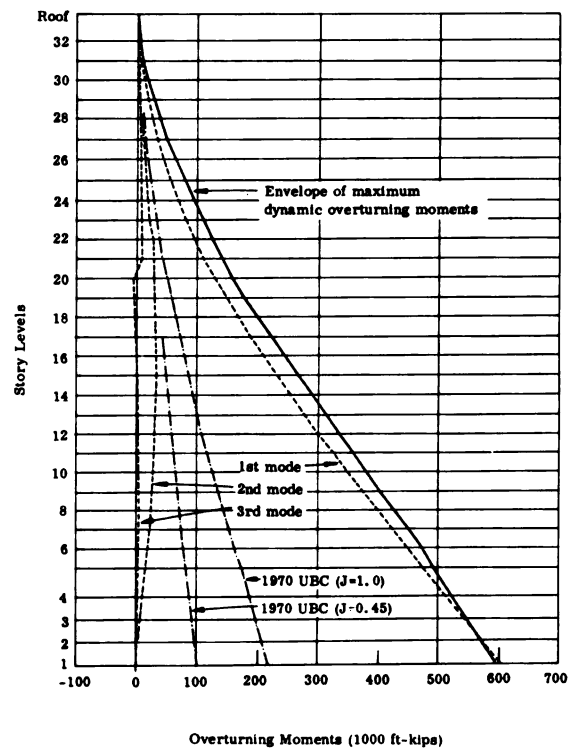
Figure 17.—Bunker Hill Tower. Dynamic response and design code values for transverse (north-south) direction.

Maximum story shears were calculated as part of the dynamic analysis. These are indicated in figures 17c and 18c along with corresponding minimum code values. For clarity, shear curves have been shown as smooth, instead of stepped-line, curves. Code design shears have been computed under the requirements of the 1970 UBC. The UBC story shears for both directions are based on the numerical coefficients and period shown in table 6.

Story shears, which were determined from the dynamic analysis indicated in figures 17c and 18c, are peak values calculated to have occurred at each floor level at some time during the earthquake excursion. These peak values, however, did not necessarily occur simultaneously and should be considered to

Comparison of overturning moments calculated in the dynamic analysis with those calculated under minimum requirements of the 1970 UBC with  $J = 0.45$  and  $J = 1.0$  also has been indicated in figures 17d and 18d. After publication of the 1970 UBC, the  $J$  factor for determining the base overturning moment was the subject of considerable scrutiny. Table 6 indicates that the 1970 UBC would require a minimum  $J$  value of 0.45 for both the transverse and longitudinal directions, but subsequent amendments to the 1970 edition of the UBC have eliminated the  $J$ -factor concept, thus, in effect, increasing the minimum  $J$  value to 1.0. For this reason, overturning moments determined with a value of  $J = 1.0$  also have been included as a comparison with the 1970 UBC prescribed minimums.
